Rail Accident Investigation Branch

# Rail Accident Report

## **Derailed at Grayrigg 23 February 2007**

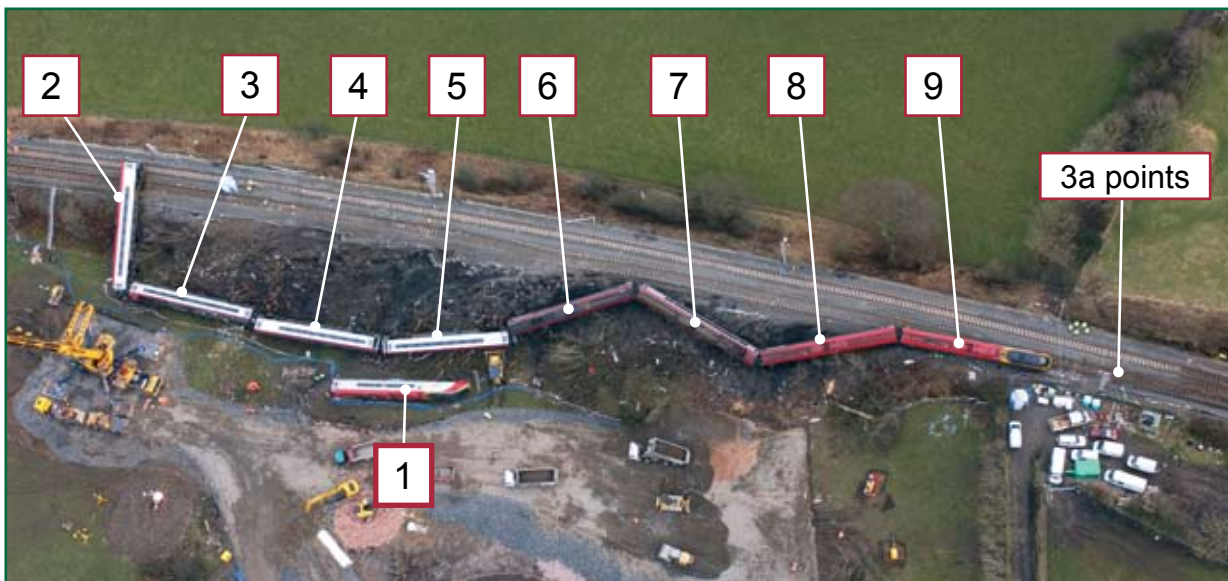
Figure 2: Aerial view of derailed train

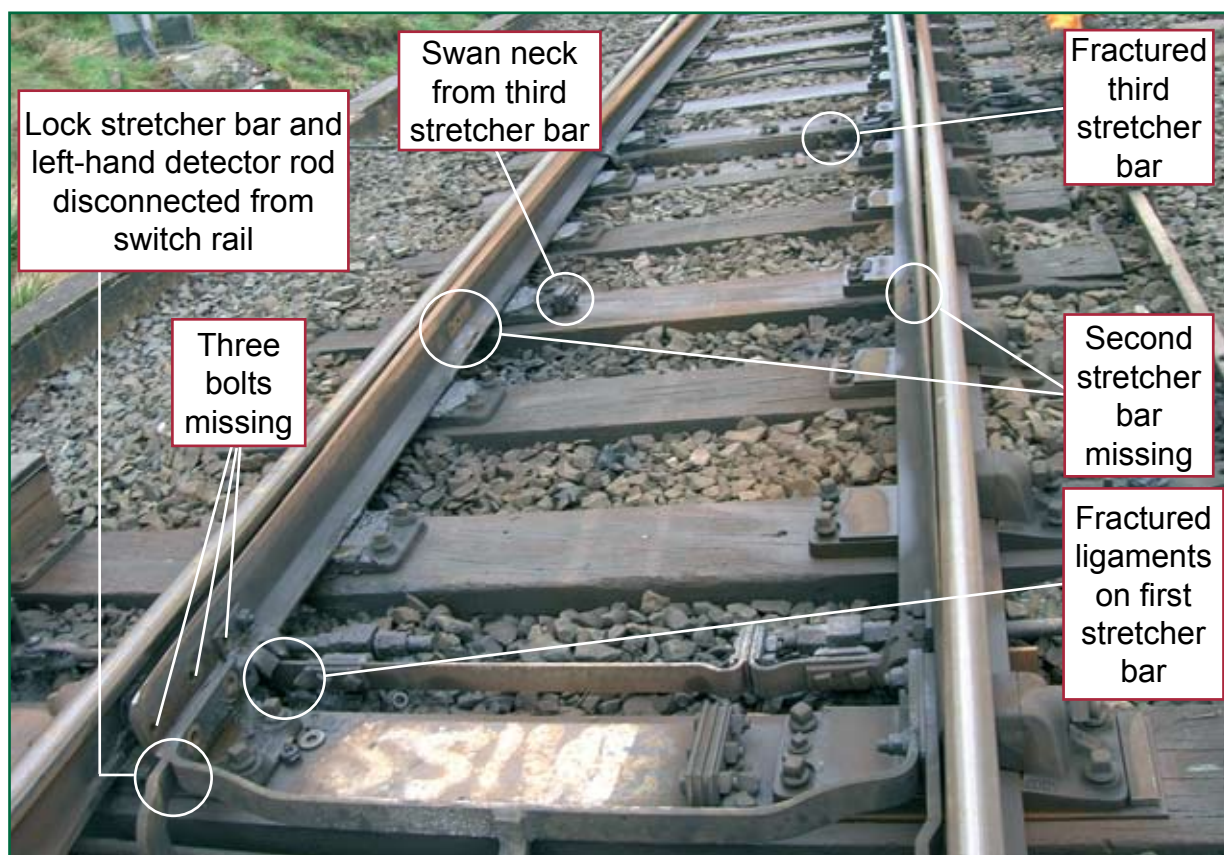
111 Figure 7 shows the state in which the points were found immediately after the accident.

Figure 7: 2B points on 24 February 2007

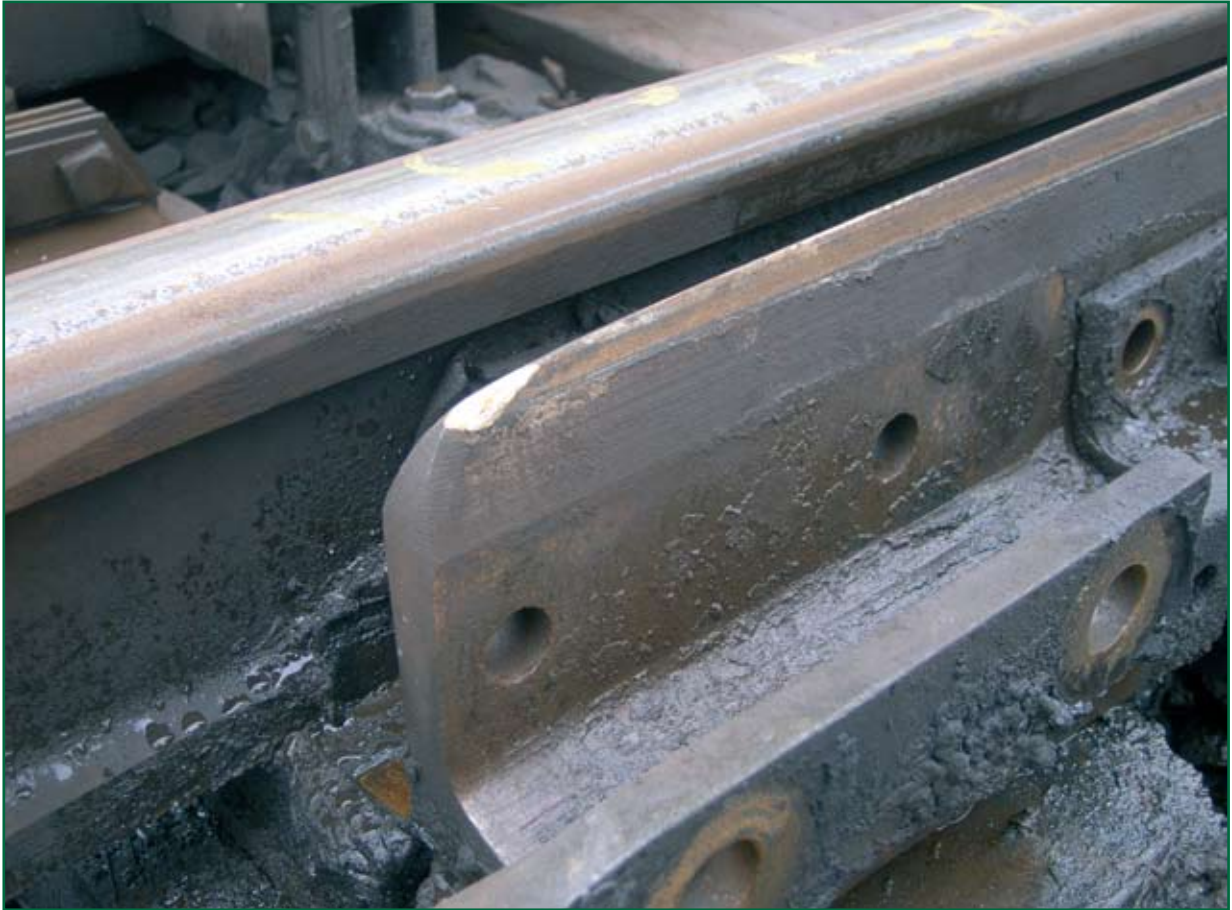
113 There was bruising on the tip of the left-hand switch rail (Figure 8) caused by impact with more than one train wheel as the wheels passed to the *gauge-side* of the left-hand switch rail during the derailment. There were wheel marks on the *field-side* face of the left-hand switch rail starting close to the switch toe and running along it, through to and beyond the third permanent way stretcher bar position (Figure 9). There were no marks indicating that any wheels had passed between the right-hand switch and stock rails from the toe to the third permanent way stretcher bar. There were flange climb marks on both switch rails in the vicinity of the third permanent way stretcher bar, and three of the left-hand *slide chairs* had fractured during the derailment because of forces tending to widen the gauge.

Figure 8: Bruise to the tip of the left-hand switch rail

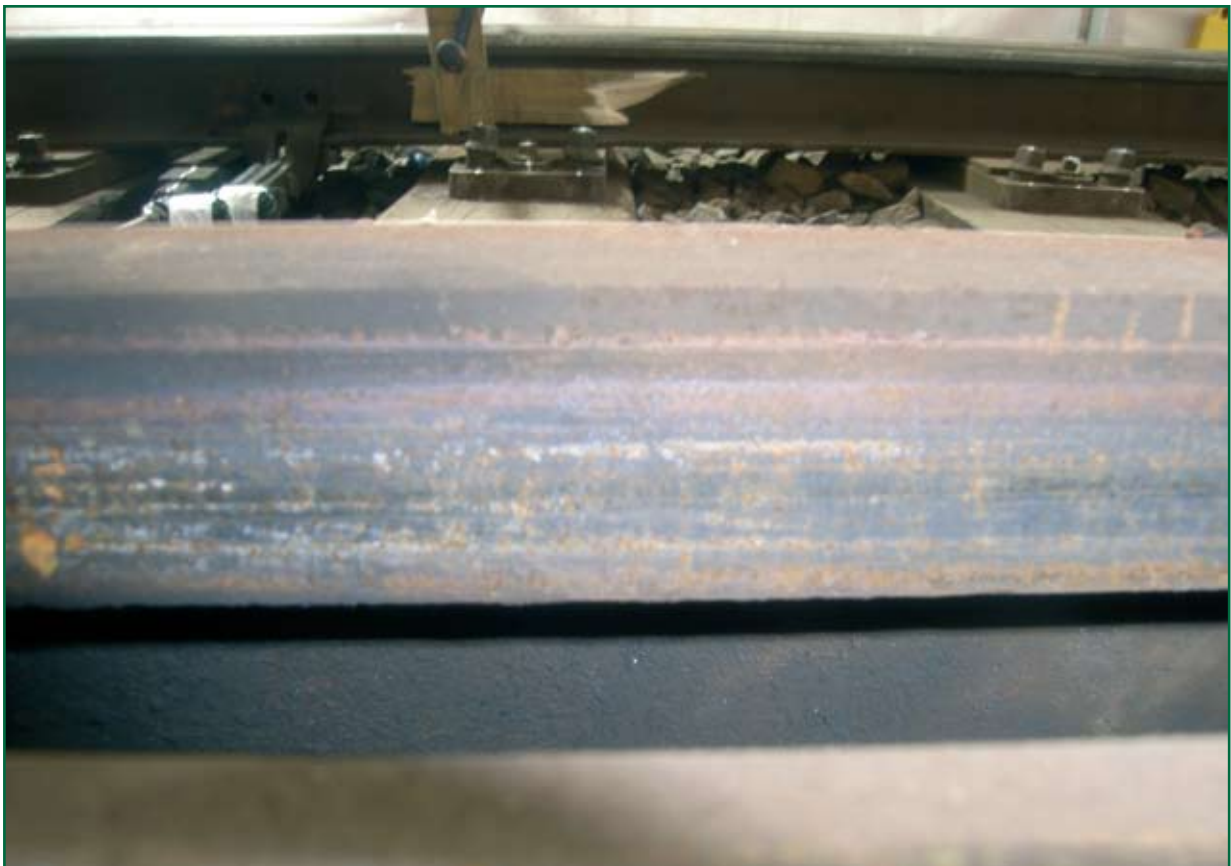
Figure 9: Wheel marks on the field side face of the left-hand switch rail

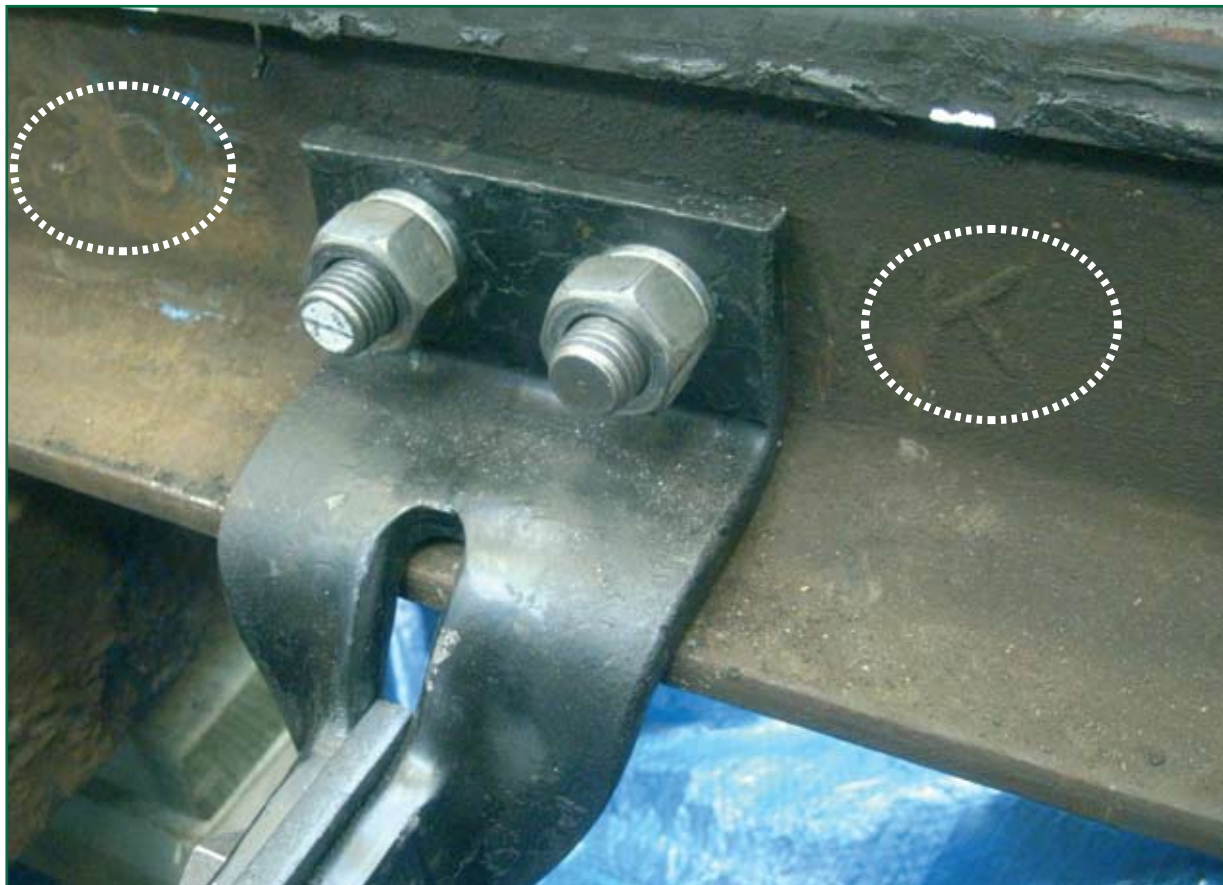
114 *Rail branding* was present on the *four-foot* side of the right-hand side switch rail where the second and third permanent way stretcher bar brackets had been attached (Figure 10). *Branding* was also present on the field-side of the left-hand switch rail where both bolt heads of the first permanent way stretcher bar and the north bolt head of the *lock stretcher bar* had been seated (Figure 11).

Figure 10: Rail branding on right-hand switch rail (Note: a new bracket has been added for testing purposes)

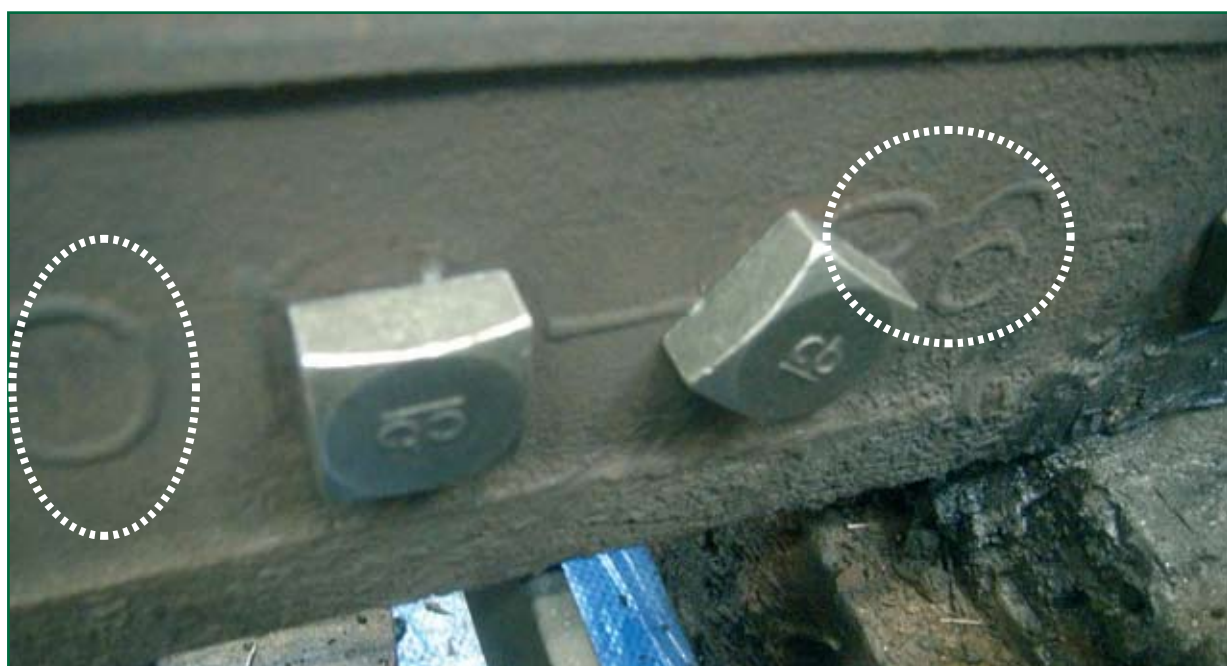
Figure 11: Rail branding on left-hand switch rail (Note: new bolts added for testing purposes)

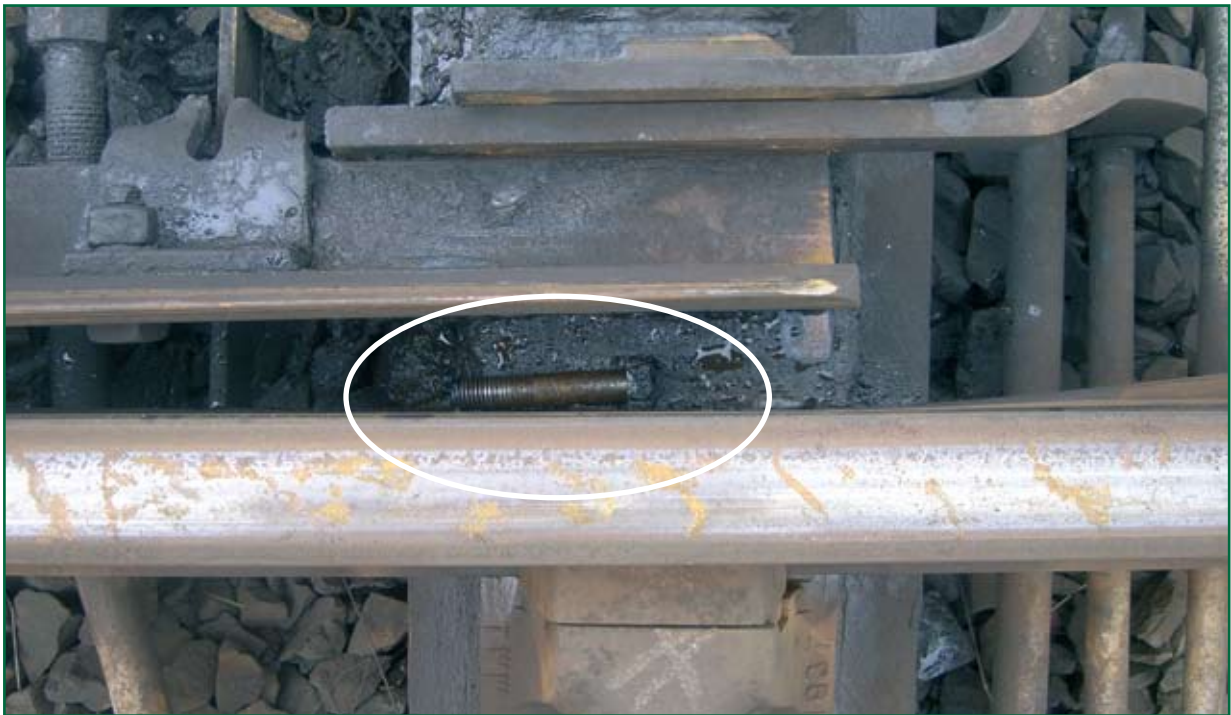
115 The lock stretcher bar was detached from the left-hand switch rail because the two fasteners were not in place. These fasteners were  $\frac{3}{4}$  inch Whitworth bolts with *prevailing torque* nuts. The bolts were made from mild steel, equivalent to grade 4.6 to British Standard 3692:2001, commonly known as black bolts, in accordance with Network Rail's specifications. All of the detached fastener components were lying in the vicinity of the switch toes, with the exception of one of the bolts which, despite an extensive search, was not found. The other lock stretcher bar bolt was recovered from the left-hand slide chair at the point toes, between the left-hand switch rail and its adjacent stock rail (Figure 12). There were markings on the bolt head (Figure 13), and the feet of both rails, consistent with the bolt having been trapped by the closing of the left-hand switch rail.

Figure 12: Lock stretcher bar bolt between left-hand switch and stock rail at toe

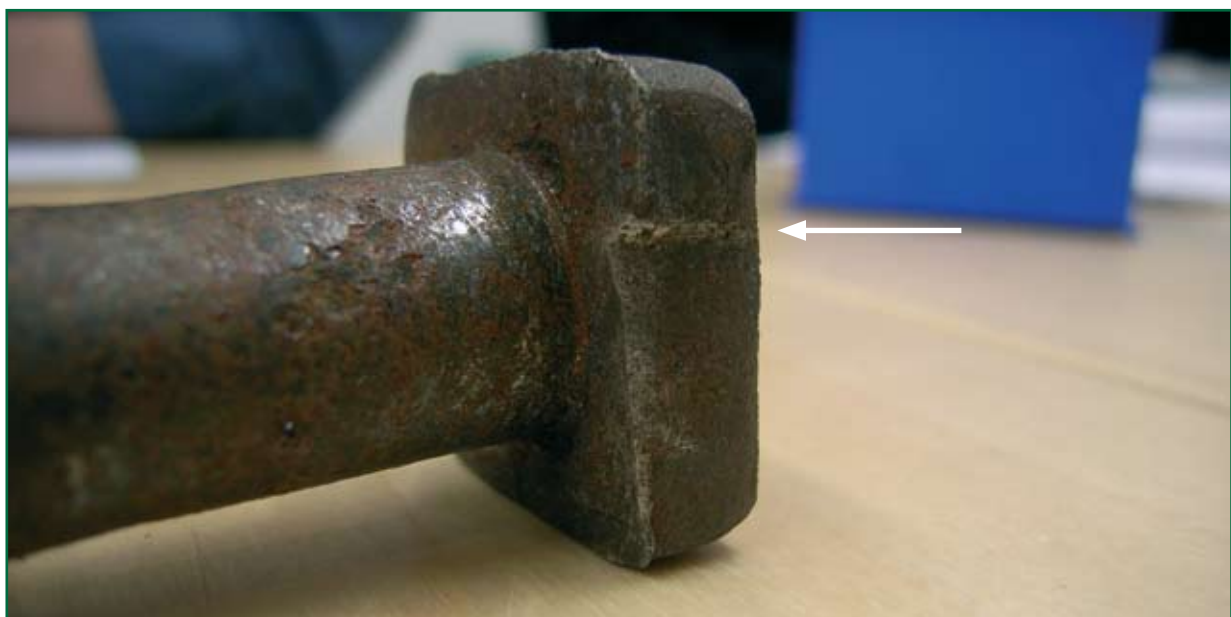
Figure 13: Indentation in lock stretcher bar bolt head

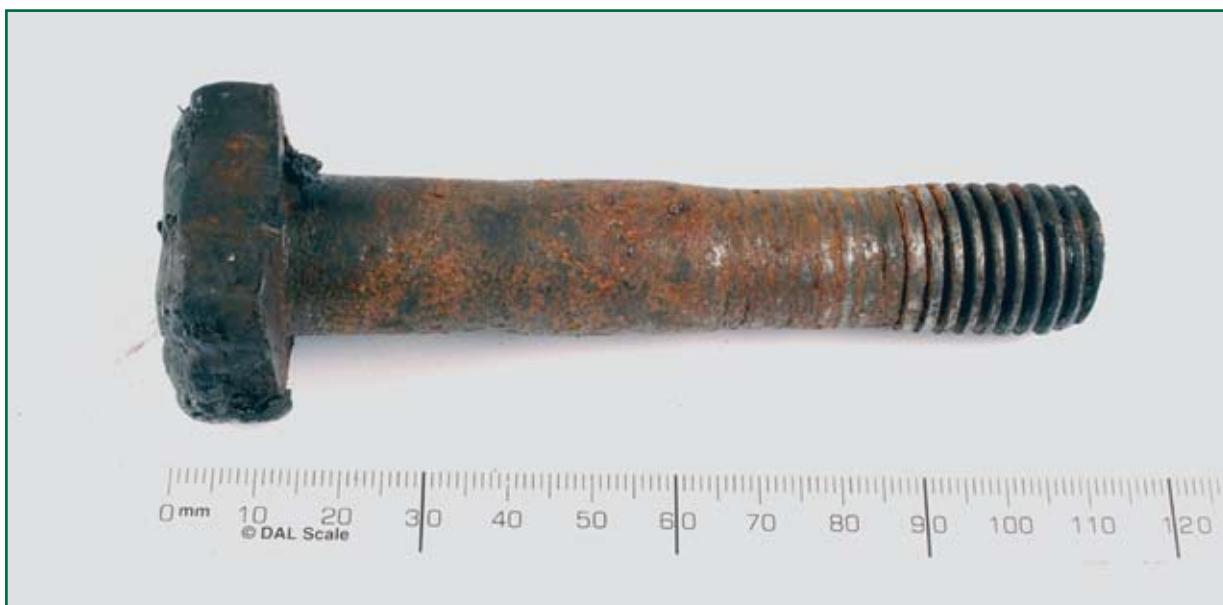
116 Examination of the one detached lock stretcher bar bolt (paragraph 115) indicated that the fastener had loosened and the nut had progressively wound off the bolt. The gradual unwinding of the nut is apparent from the decreasing flattening of the crowns of the threads towards the tip of the bolt (Figure 14).

Figure 14: Lock stretcher bar bolt showing progressive thread damage

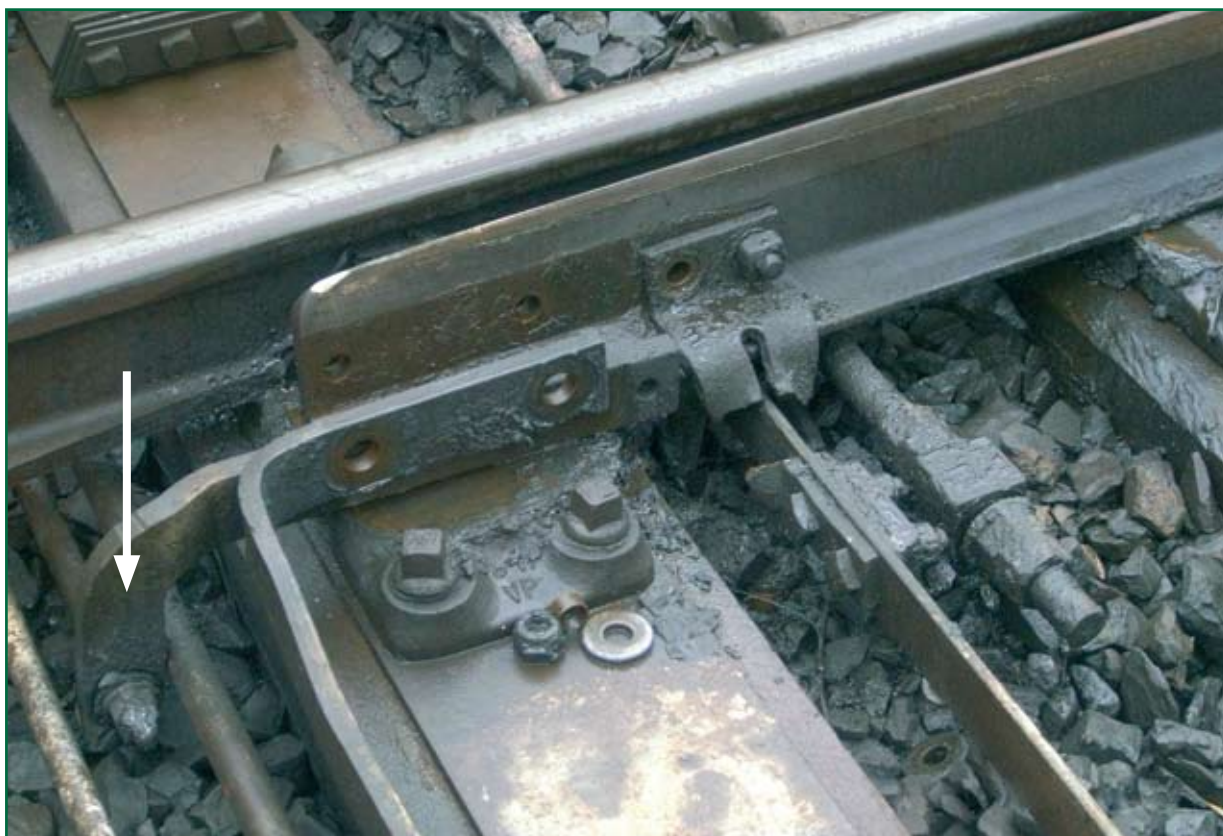
117 The left-hand *switch rail extension piece* (Figure 15), to which the *detector rod* was attached, was also detached from the left-hand switch rail because its fasteners were common with those of the lock stretcher bar.

Figure 15: Left-hand switch rail toe showing switch rail extension piece (arrowed)

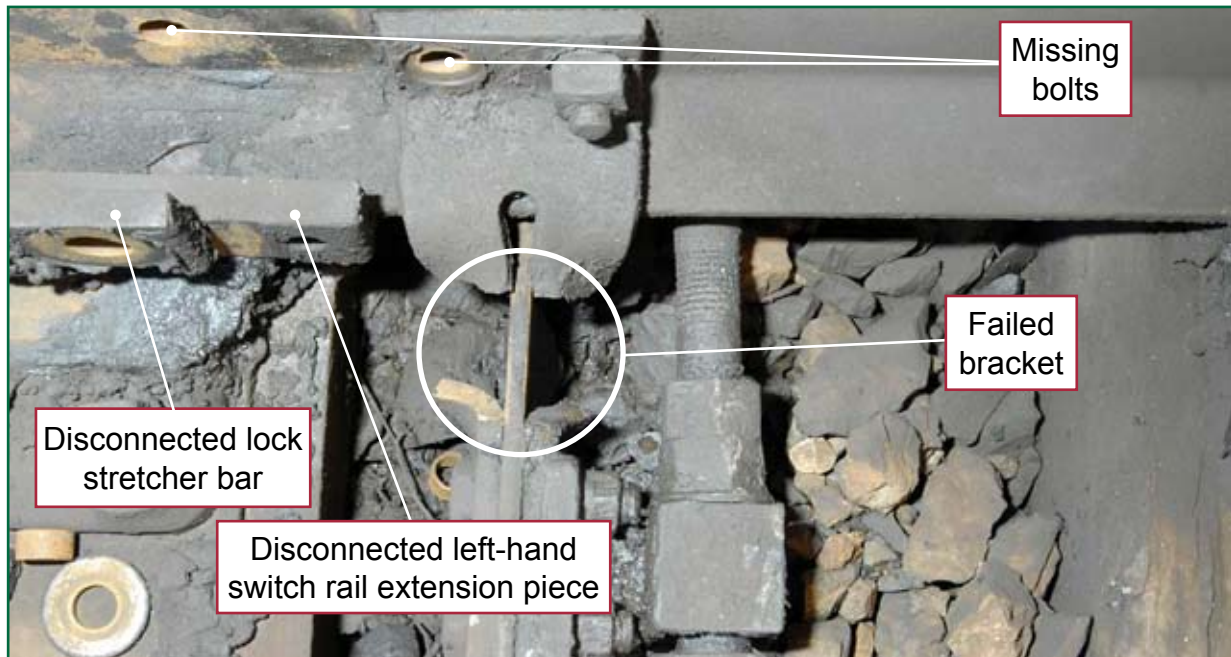
Figure 16: Failed bracket first permanent way stretcher bar

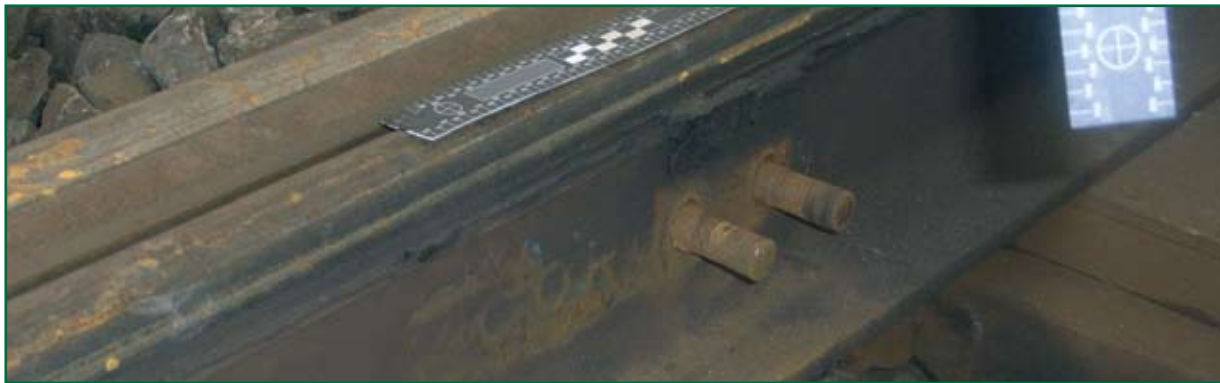
- 122 The second permanent way stretcher bar was missing from the points. All of its fastener components (bolts, nuts and spring washers) were present in the ballast in the vicinity of where the bar had been, with the exception of the right-hand switch rail bolts which were still within their attachment holes in the right-hand switch rail (Figure 17).
- 123 Two sections of stretcher bar (Figures 18 and 19) were found at two separate locations 50 metres and 150 metres north of 2B points. Their dimensions and metallurgy indicated that these were the sections of the second permanent way stretcher bar.

Figure 17: Right-hand switch rail at second permanent way stretcher bar position

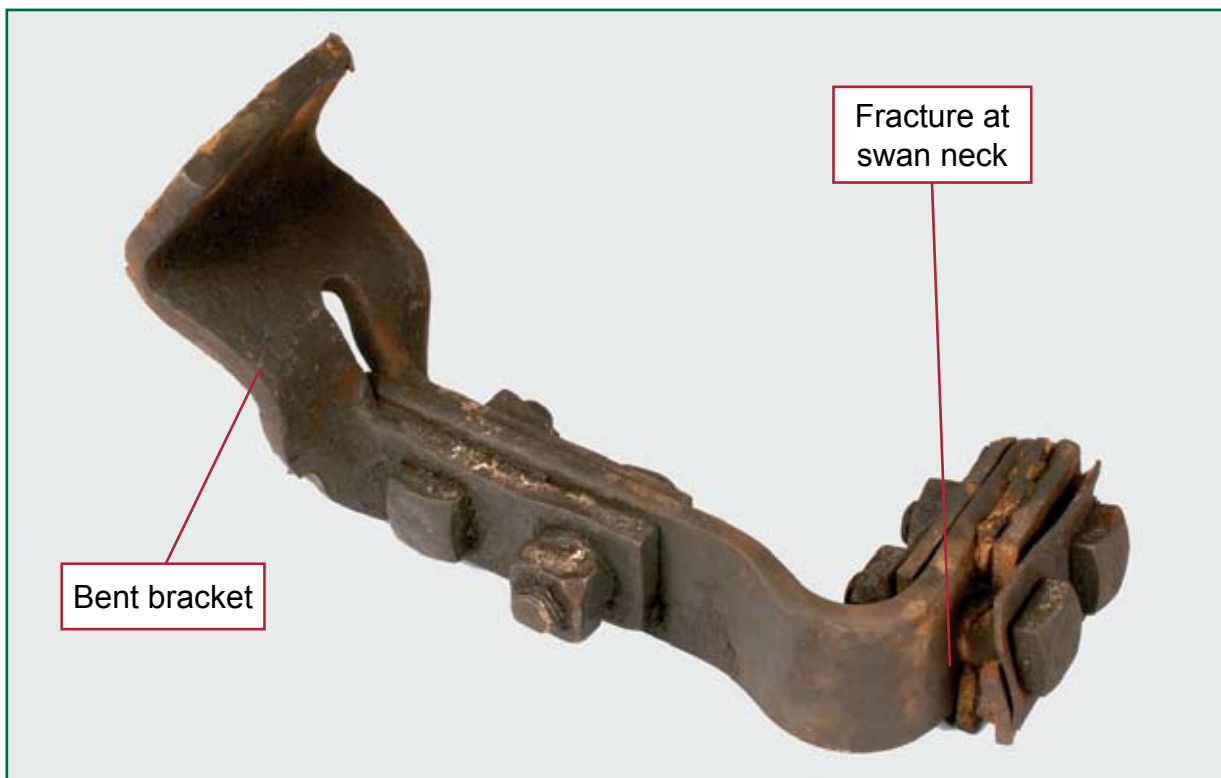
Figure 18: Short section of second permanent way stretcher bar

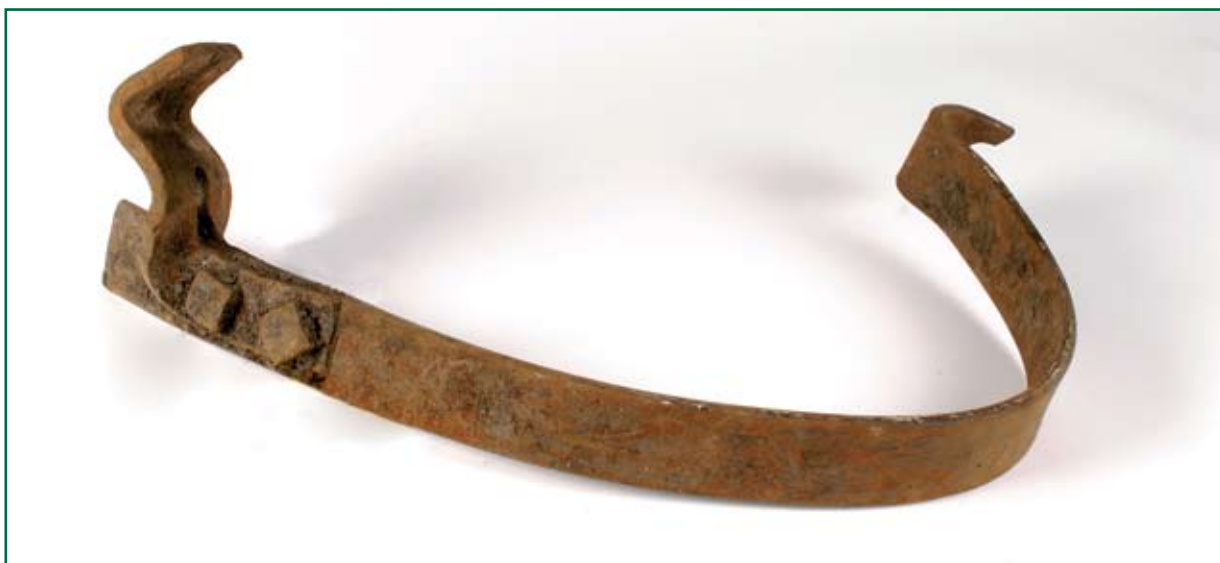
Figure 19: Long section of second permanent way stretcher bar

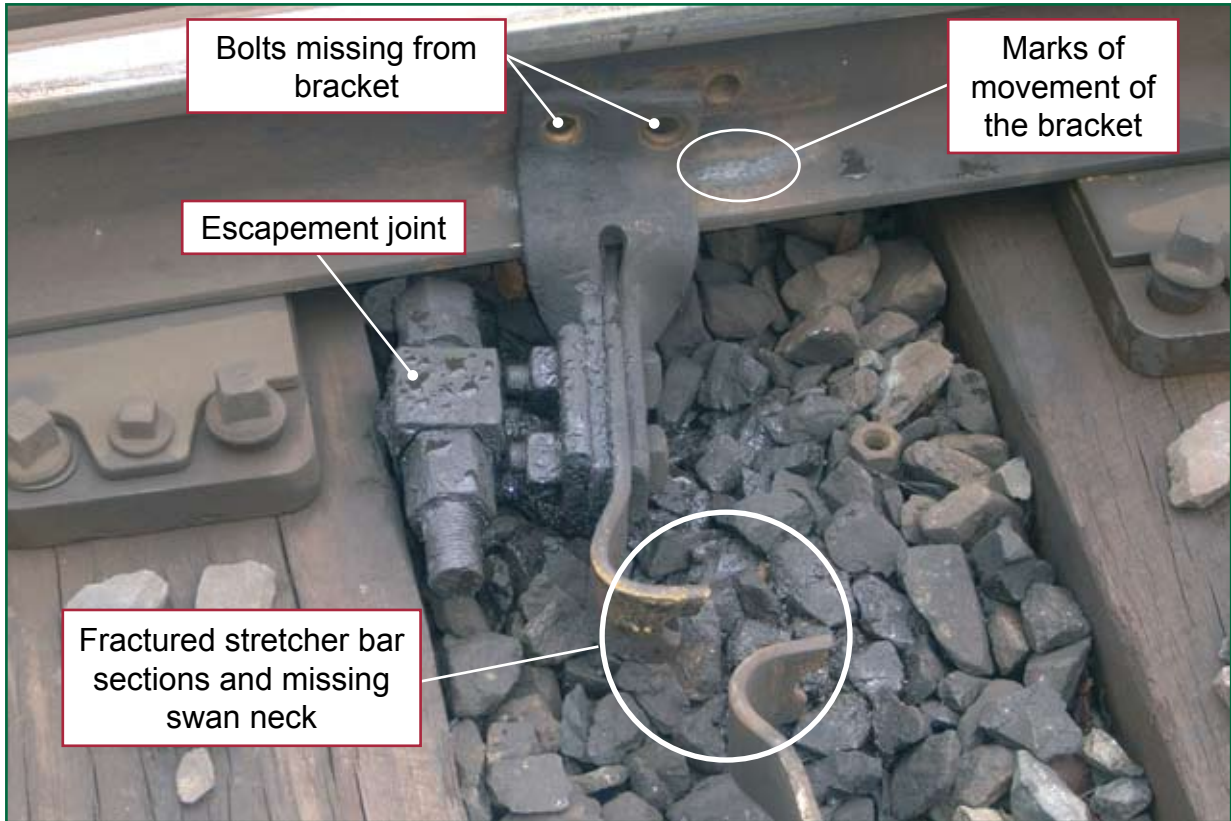
124 The third permanent way stretcher bar was found in place but broken in two places (Figure 20). The *swan neck insulation* assembly was found on the third *bearer* from the point toes in the direction of travel close to the left-hand slide chair (Figures 7 and 21).

Figure 20: The third permanent way stretcher bar

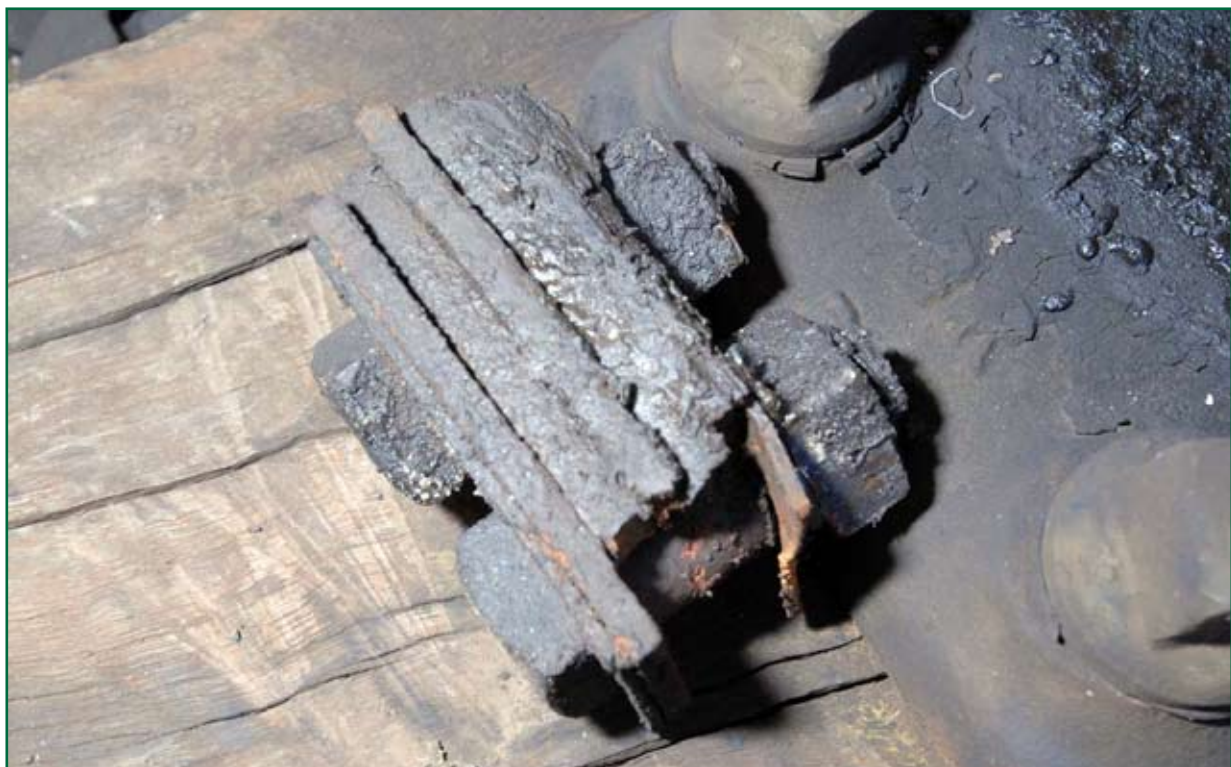
Figure 21: The third permanent way stretcher bar swan neck insulation assembly

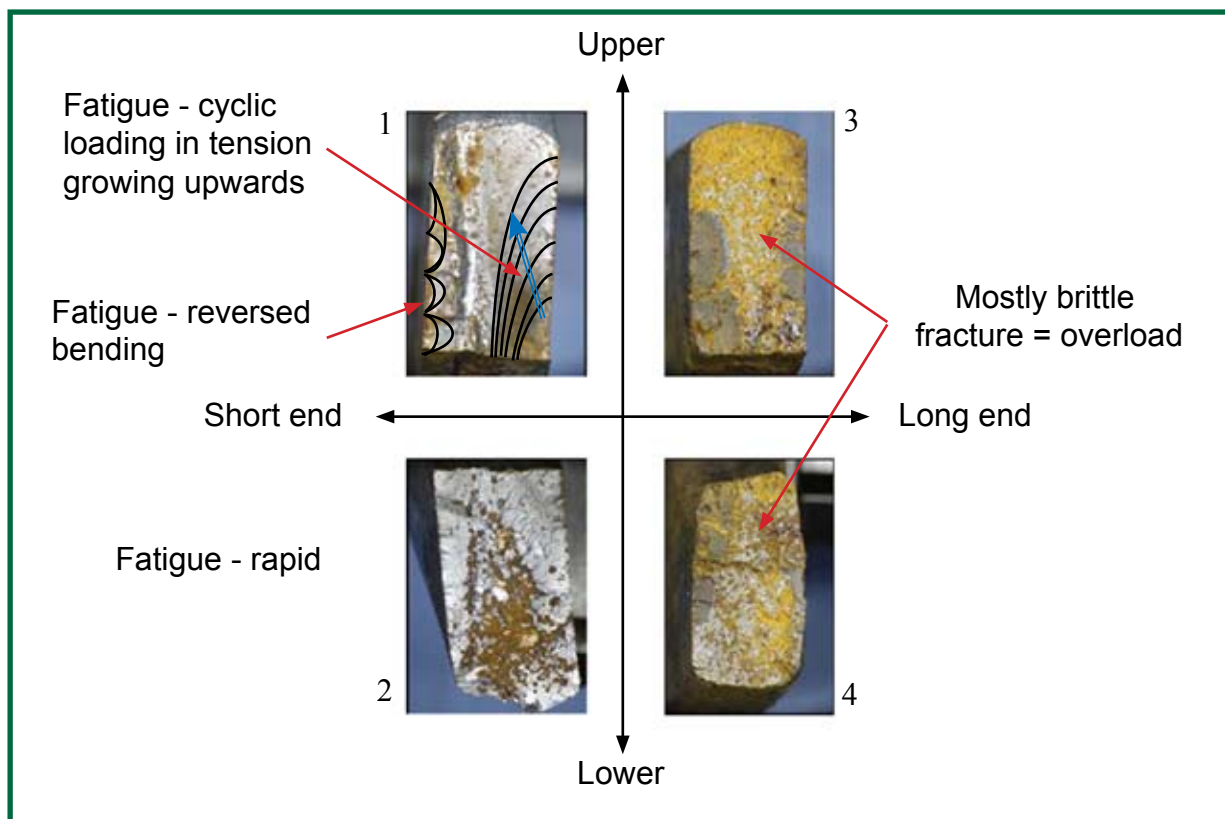
125 The broken components in the third permanent way stretcher bar swan neck insulation assembly had new, corrosion-free fracture surfaces. Additionally there was evidence of older fatigue. The four fracture surfaces in the swan neck insulation assembly are shown in Figure 22.

Figure 22: Fatigue surfaces within the swan neck assembly of the third permanent way stretcher bar

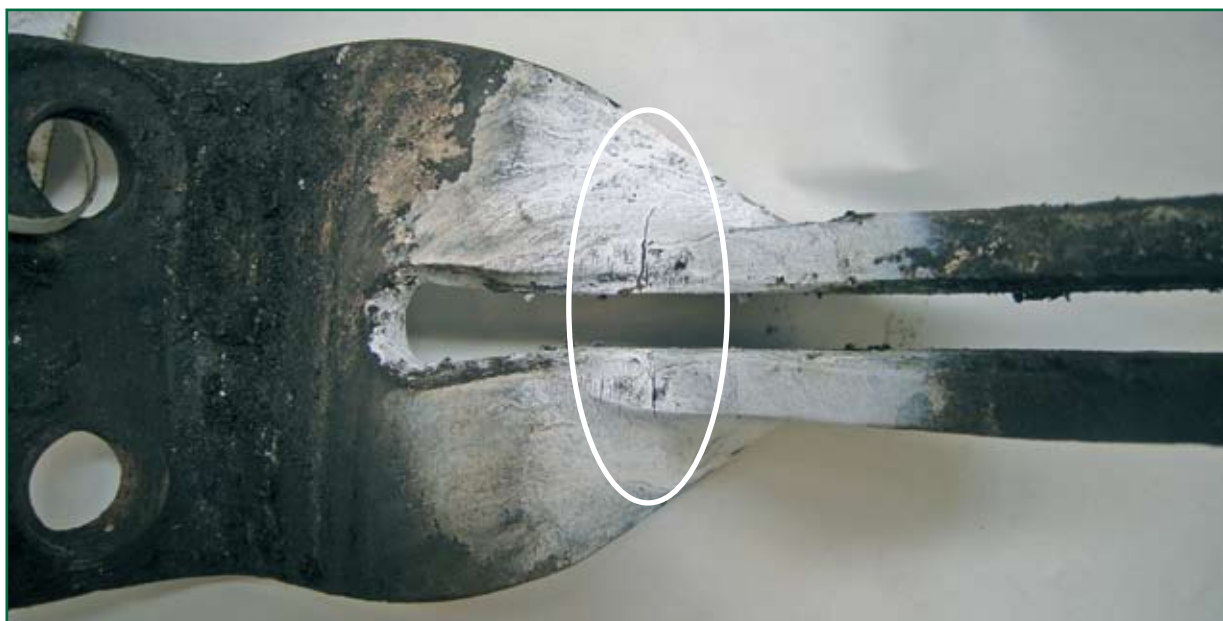
126 There were also cracks in the ligaments of both the left and right-hand switch rail brackets (Figure 23).

Figure 23: Cracks in the left-hand rail bracket of the third permanent way stretcher bar

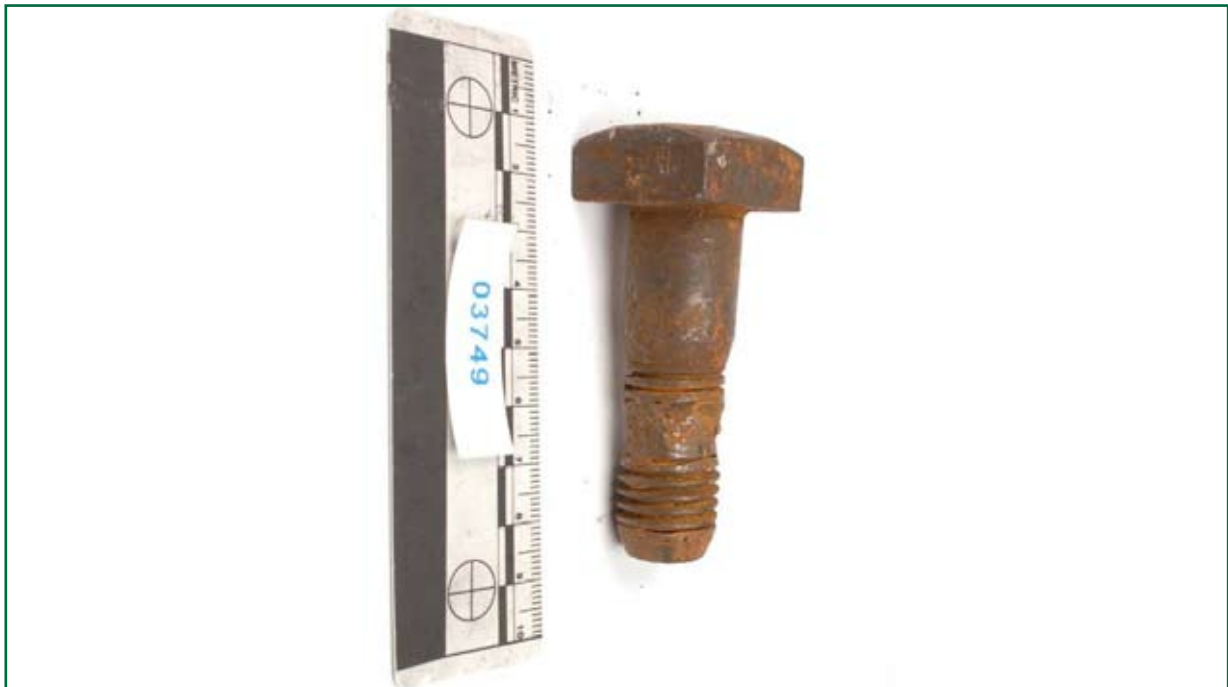
- 127 The right-hand bracket of the stretcher bar was detached from the right-hand switch rail and was supported only by its connection to the supplementary drive (Figure 20).
- 128 Four bolts and four nuts (all  $\frac{3}{4}$  inch Whitworth) and two single coil spring washers were found in close proximity to the third permanent way stretcher bar. All of the bolts exhibited signs of damage consistent with being loosely held within the switch rail holes prior to working free. Three of the bolts had sustained damage consistent with being trapped for a while between the closed right-hand switch and stock rails before falling free (Figure 24).

Figure 24: Damaged bolt from right-hand end bracket of third permanent way stretcher bar

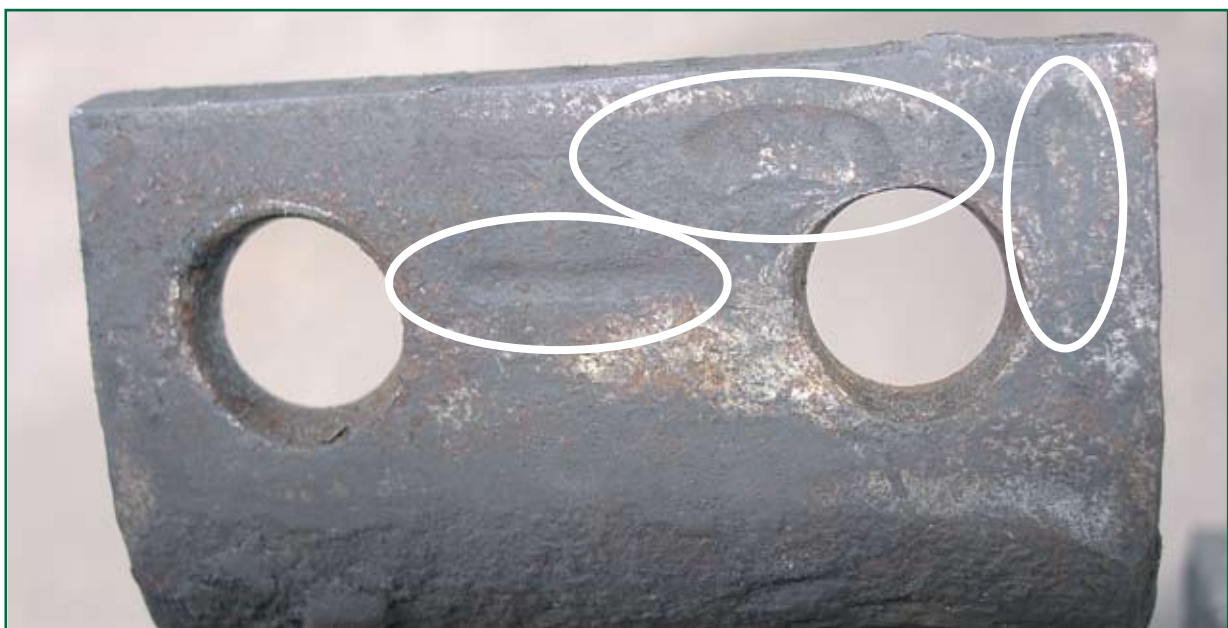
- 129 There were indentations matching the rail branding (paragraph 114) imprinted into the mating face of the right-hand stretcher bar bracket (Figure 25).

Figure 25: Indentations imprinted into the mating face

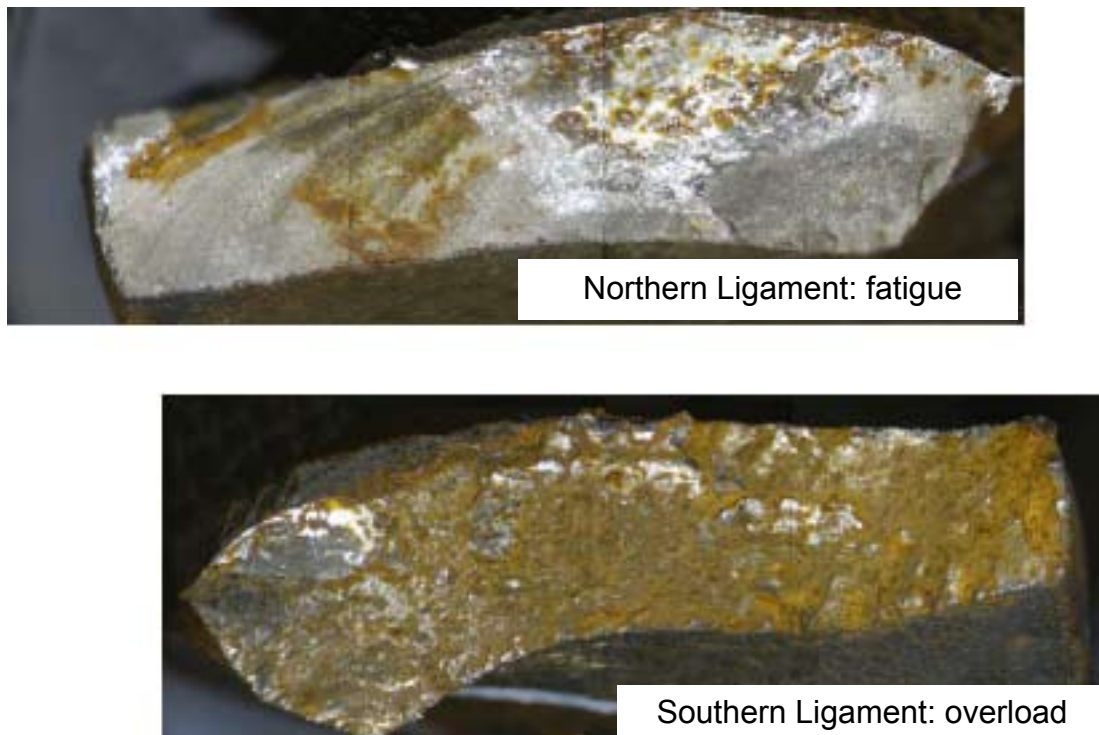
160 Testing in the laboratory demonstrated that the forces in the remaining stretcher bars increase following the loss of the third permanent way stretcher bar. Testing on the network and in the laboratory indicated that greater flange-back contact resulted in an increase in forces experienced by the remaining stretcher bars. The magnitude of these forces was sufficient to overcome the clamping force on both rail bracket joints on the second permanent way stretcher bar. The failure of these joints resulted in a further increase in flange-back contact to a level of between 34 mm and 46 mm and led to the failure of the left-hand joints of the lock and first permanent way stretcher bars. While the left-hand switch rail continued to be struck, the left-hand switch rail bracket of the first permanent way stretcher bar failed at both of the ligaments where it joins the stretcher bar itself. The northerly fracture was by fatigue and the southerly by *brittle overload* (Figure 29). The RAIB has not been able to determine the order in which the final failures occurred.

Figure 29: Fatigue and mechanical failure surfaces in ligaments of first stretcher bar bracket

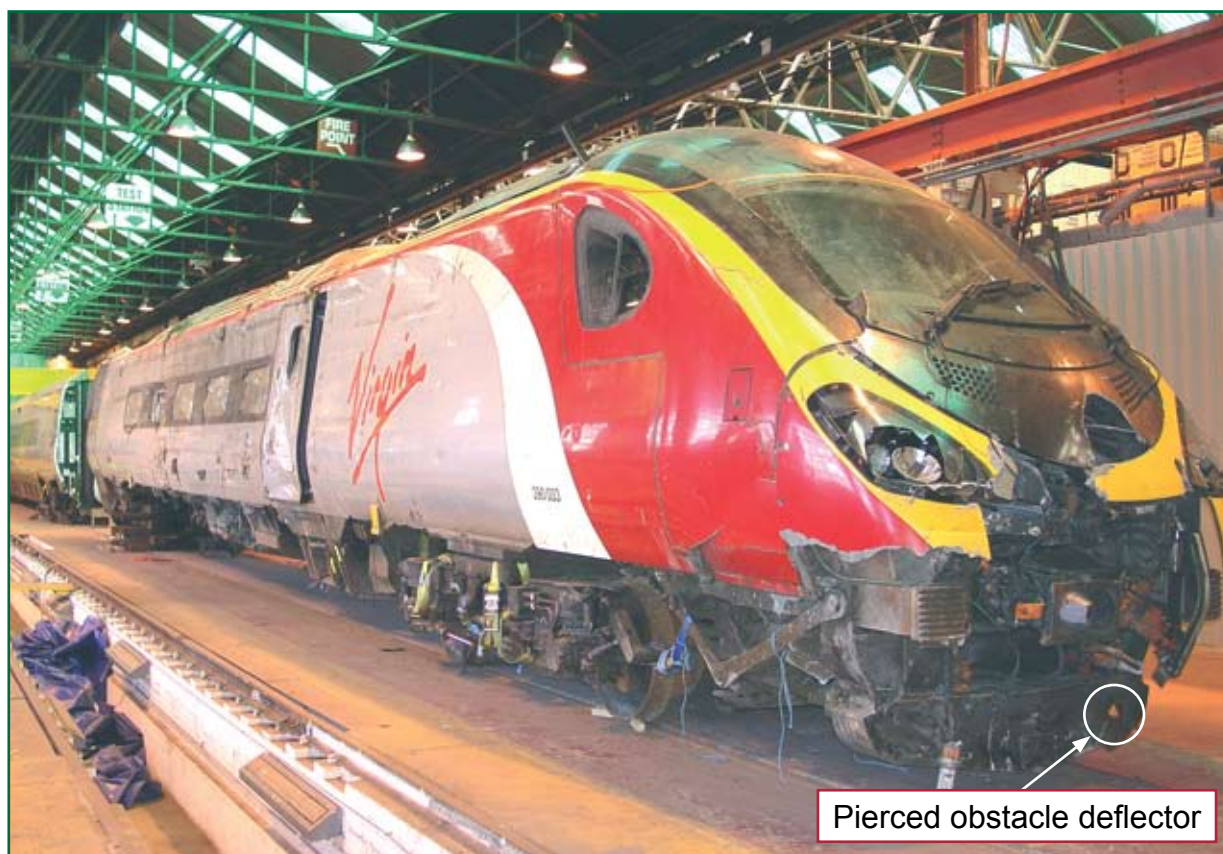
548 As a consequence of the derailment, vehicle one suffered damage to the leading and trailing ends and the right-hand body side, which was buckled and severely scored (Figure 37). The floor was distorted and underframe-mounted equipment was severely damaged. There were concentrated impact damage marks at the two positions along the right-hand cantrail where it had struck overhead line equipment masts (paragraphs 543 and 544) but there was no loss of survival space or penetration through the body structure. Damage to the left-hand side was confined to the leading door and underframe equipment.

Figure 37: Damage to the right-hand bodyside of vehicle one and obstacle deflector

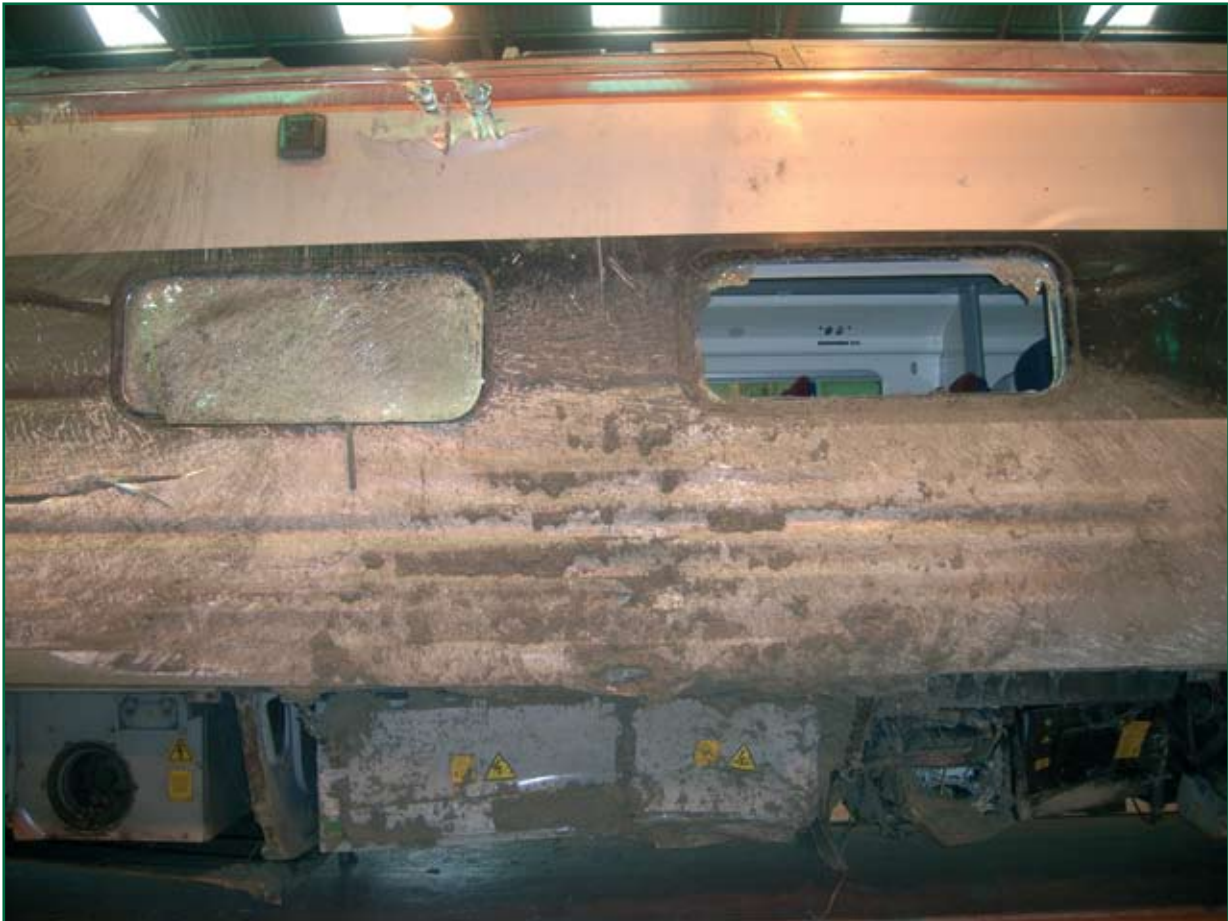
550 Vehicle two sustained damage to both leading and trailing ends, particularly at the left-hand corner of the trailing end which had been pushed in by approximately 320 mm. This localised damage probably occurred when it slid down the embankment on its side, at the end of its travel, and hit the ground before it came to rest. The left-hand side was severely scored by sliding on ballast and had been pushed in by approximately 160 mm at the central section (Figure 38). The right-hand body side was scarcely damaged. Three of the four external doors were jammed in the closed position but this did not hamper evacuation as explained at paragraph 565. Both bogies were damaged but remained attached to the body. The coupler attaching vehicle two to vehicle three had parted at its central connection.

Figure 38: Damaged central section of the left-hand bodyside of vehicle two
